Roane County Sheriff's Office & Jail
300 East Race Street
Kingston, Tennessee

March 2011

Executive Summary #10

Jail Reuse Study

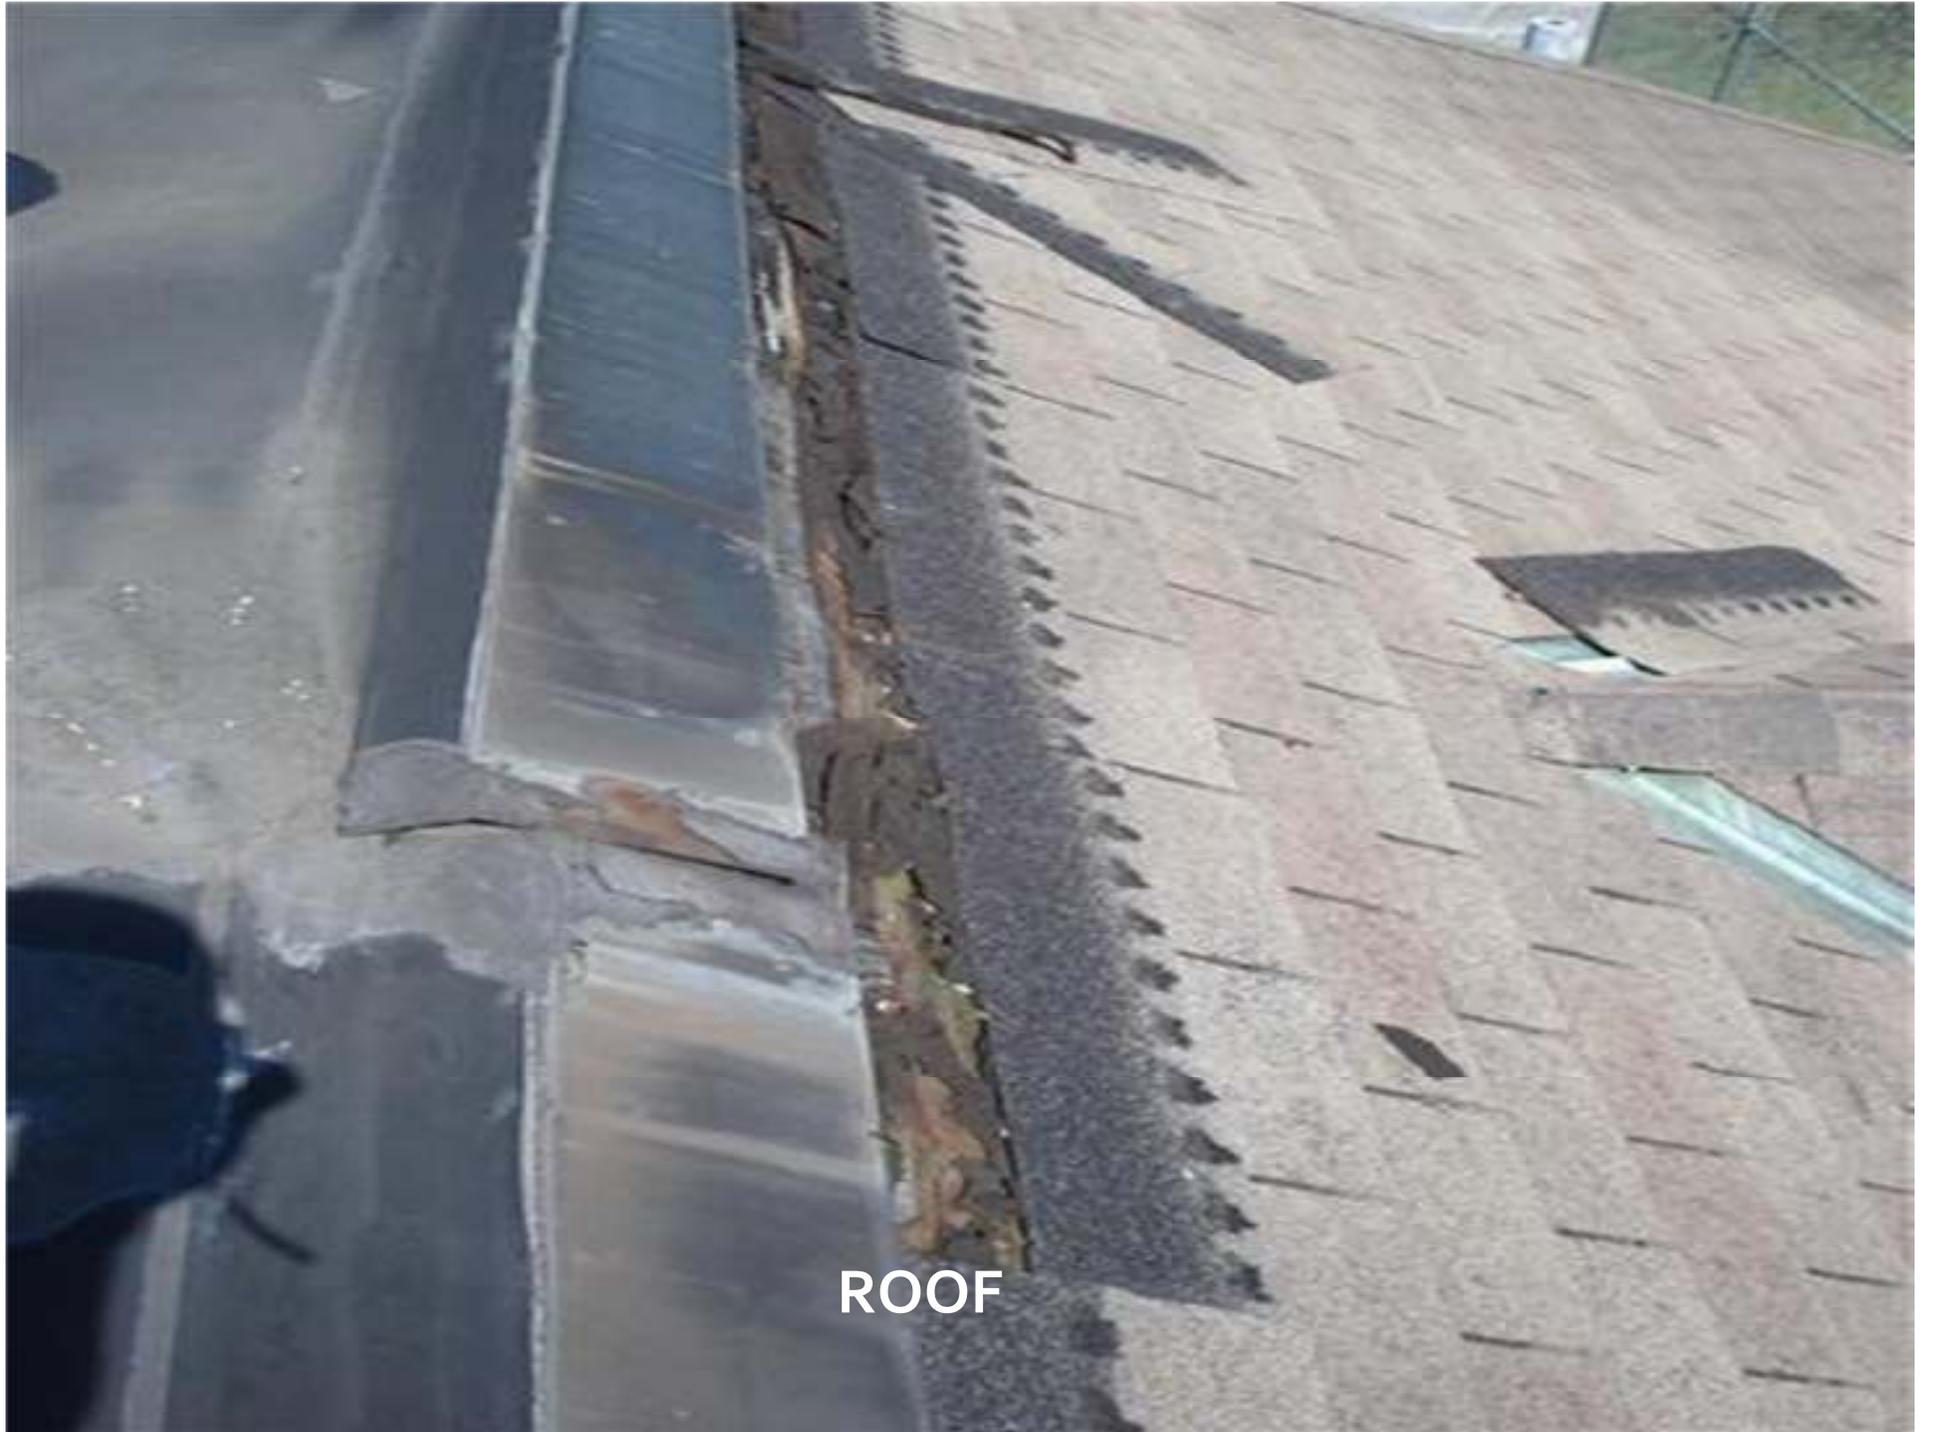
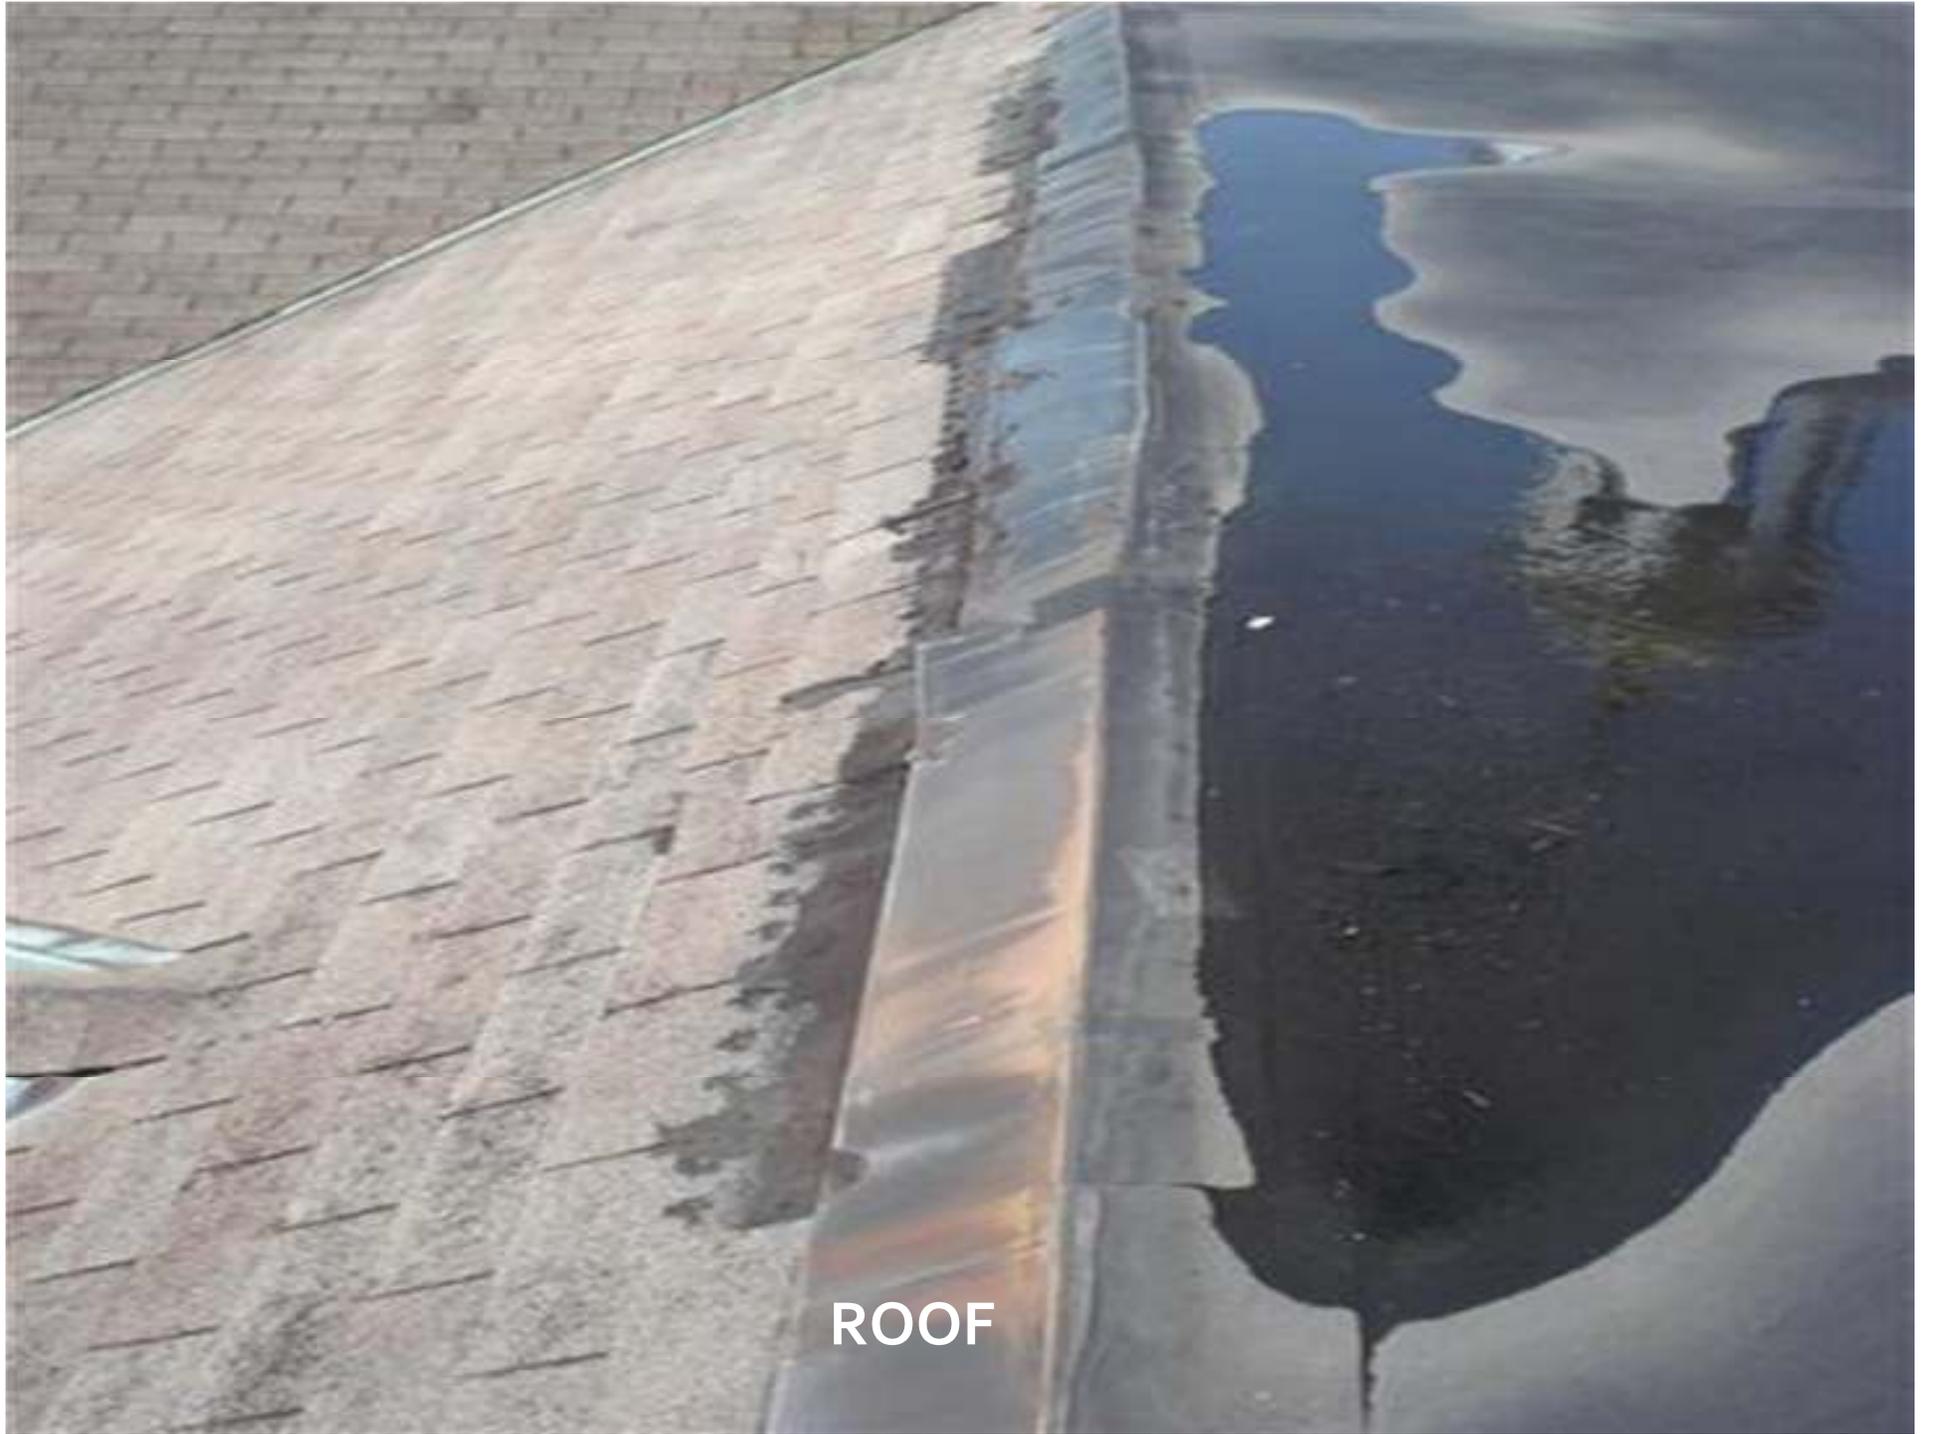
ROOF

- Roof is nearing the end of its functional life
- West side eave is damaged due to a faulty gutter/downspout connection
- Entry door will have to be replaced to provide emergency egress
- An additional means of egress is required on north side of building
- Building will require the installation of an ADA compliant toilet

- Repair structural damage, make needed cosmetic repairs & replace roof
- Install new entry door and windows
- Install an ADA compliant toilet
- Refresh interior finishes, new ceiling tiles & grids, remove existing insulation & replace with blown in insulation
- Demolish exercise yard walls
- Install egress on north side

- **Roof** (Flat & Shingled) and repair damaged **wood fascia & cornice** Estimate **\$70,000** (includes engineering)
- Take down the recreation area- Estimate **<\$8,000**
- Clean up the facility including- Estimate **\$10,000**
 - Ceiling tiles removal only
 - Painting of walls and cells
- Reevaluate the use
 - Public records storage in cell area
 - Sheriff's evidence storage
 - Property Committee recommendations???

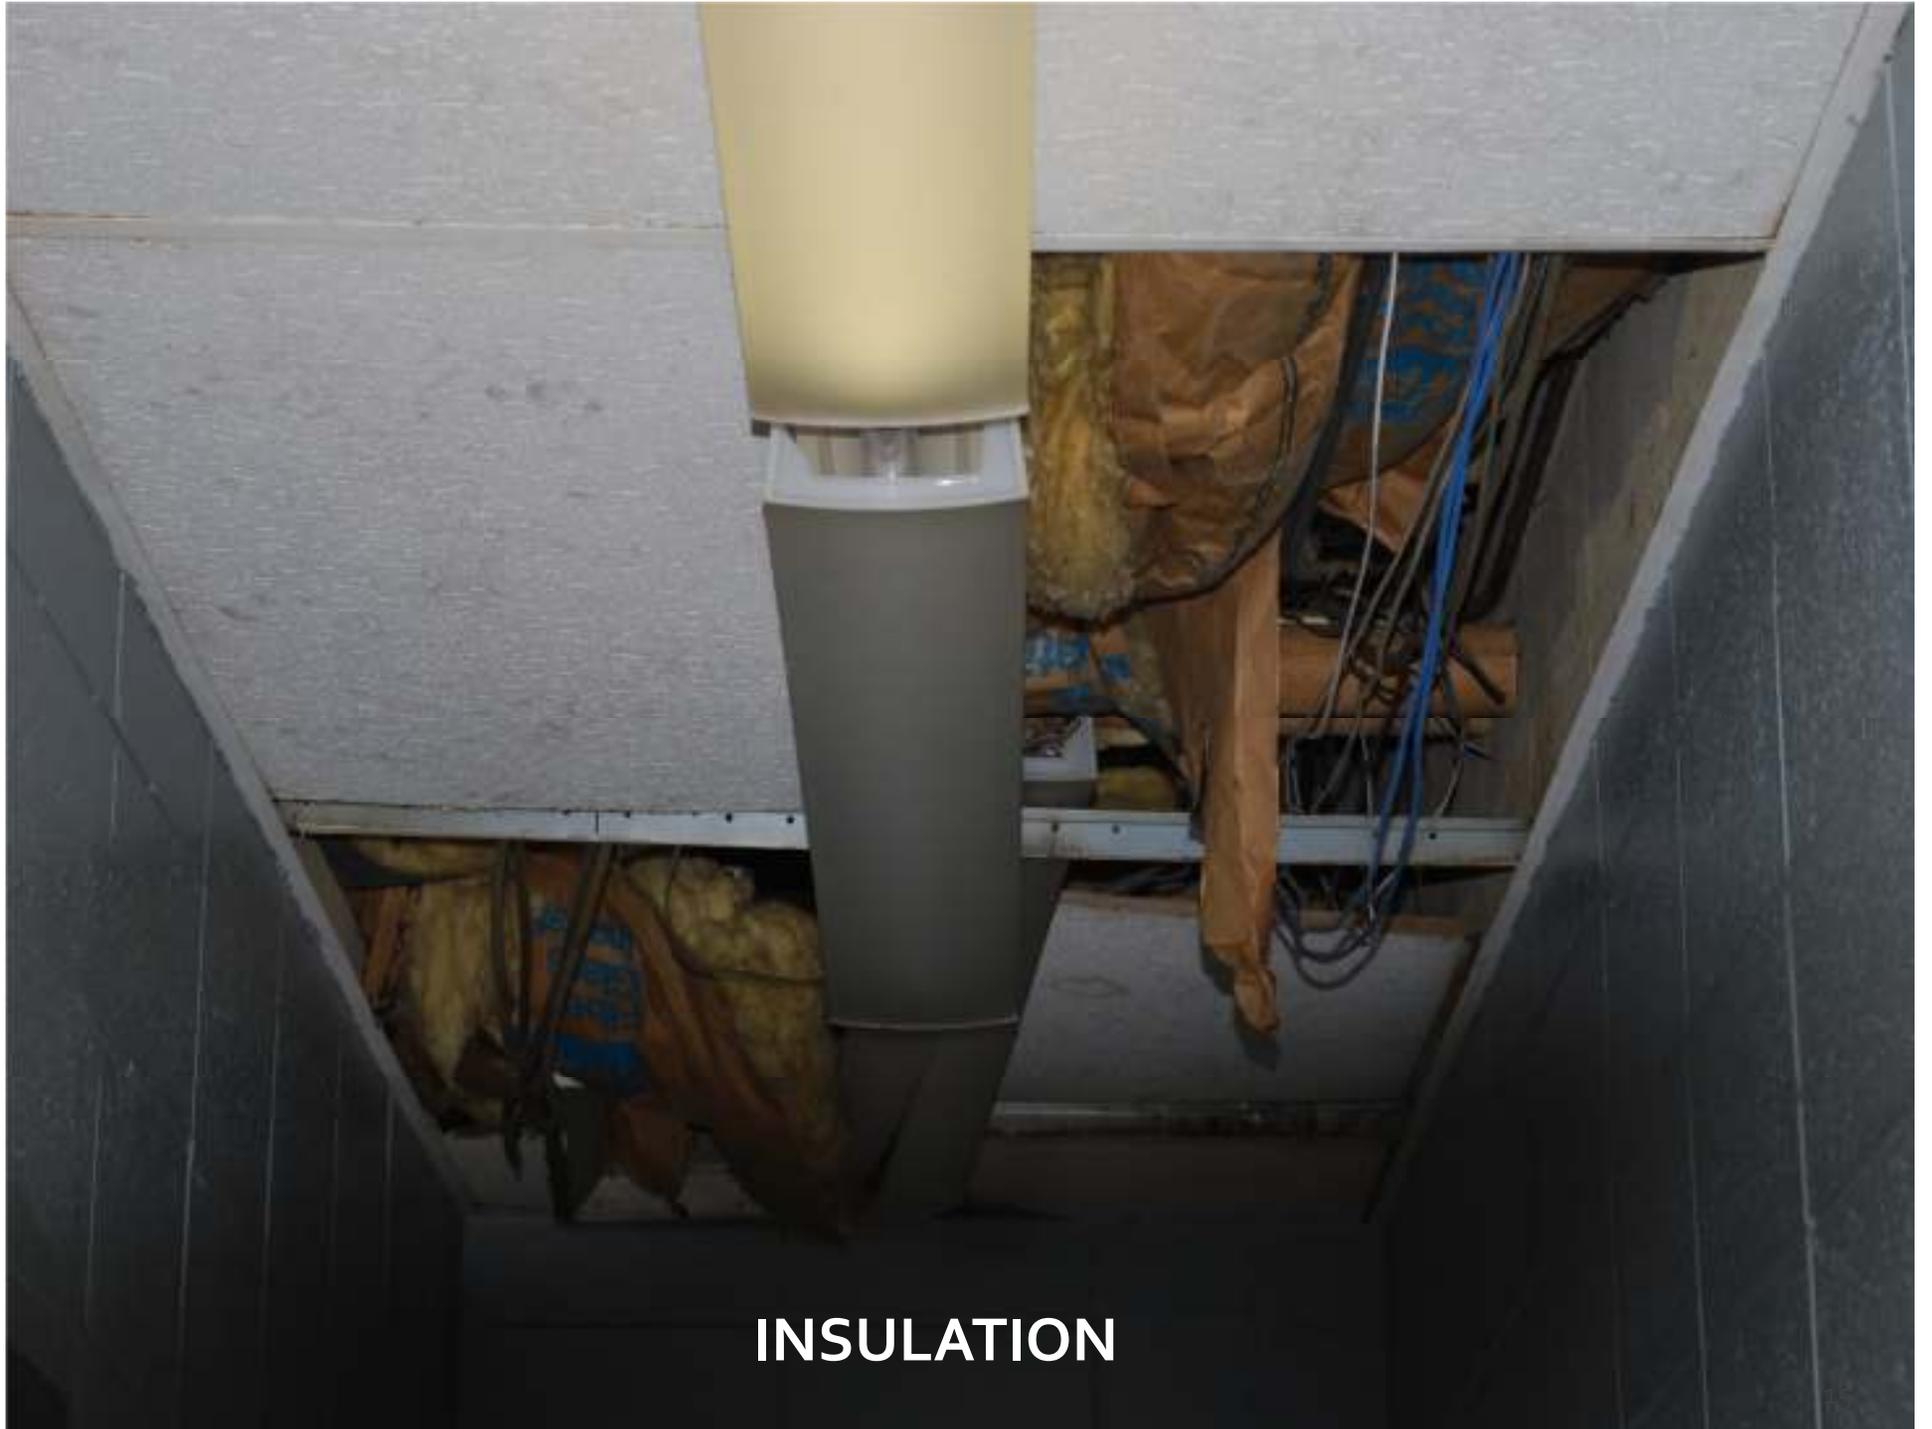
INSULATION

- Existing insulation has been exposed to 30 years of jail use and is installed at improper locations
- The ceiling tiles & grids are in poor condition
- The structural soundness of the exercise yard walls is unknown
- Existing windows have been tinted and barred and otherwise modified
- Other exterior cosmetic repairs

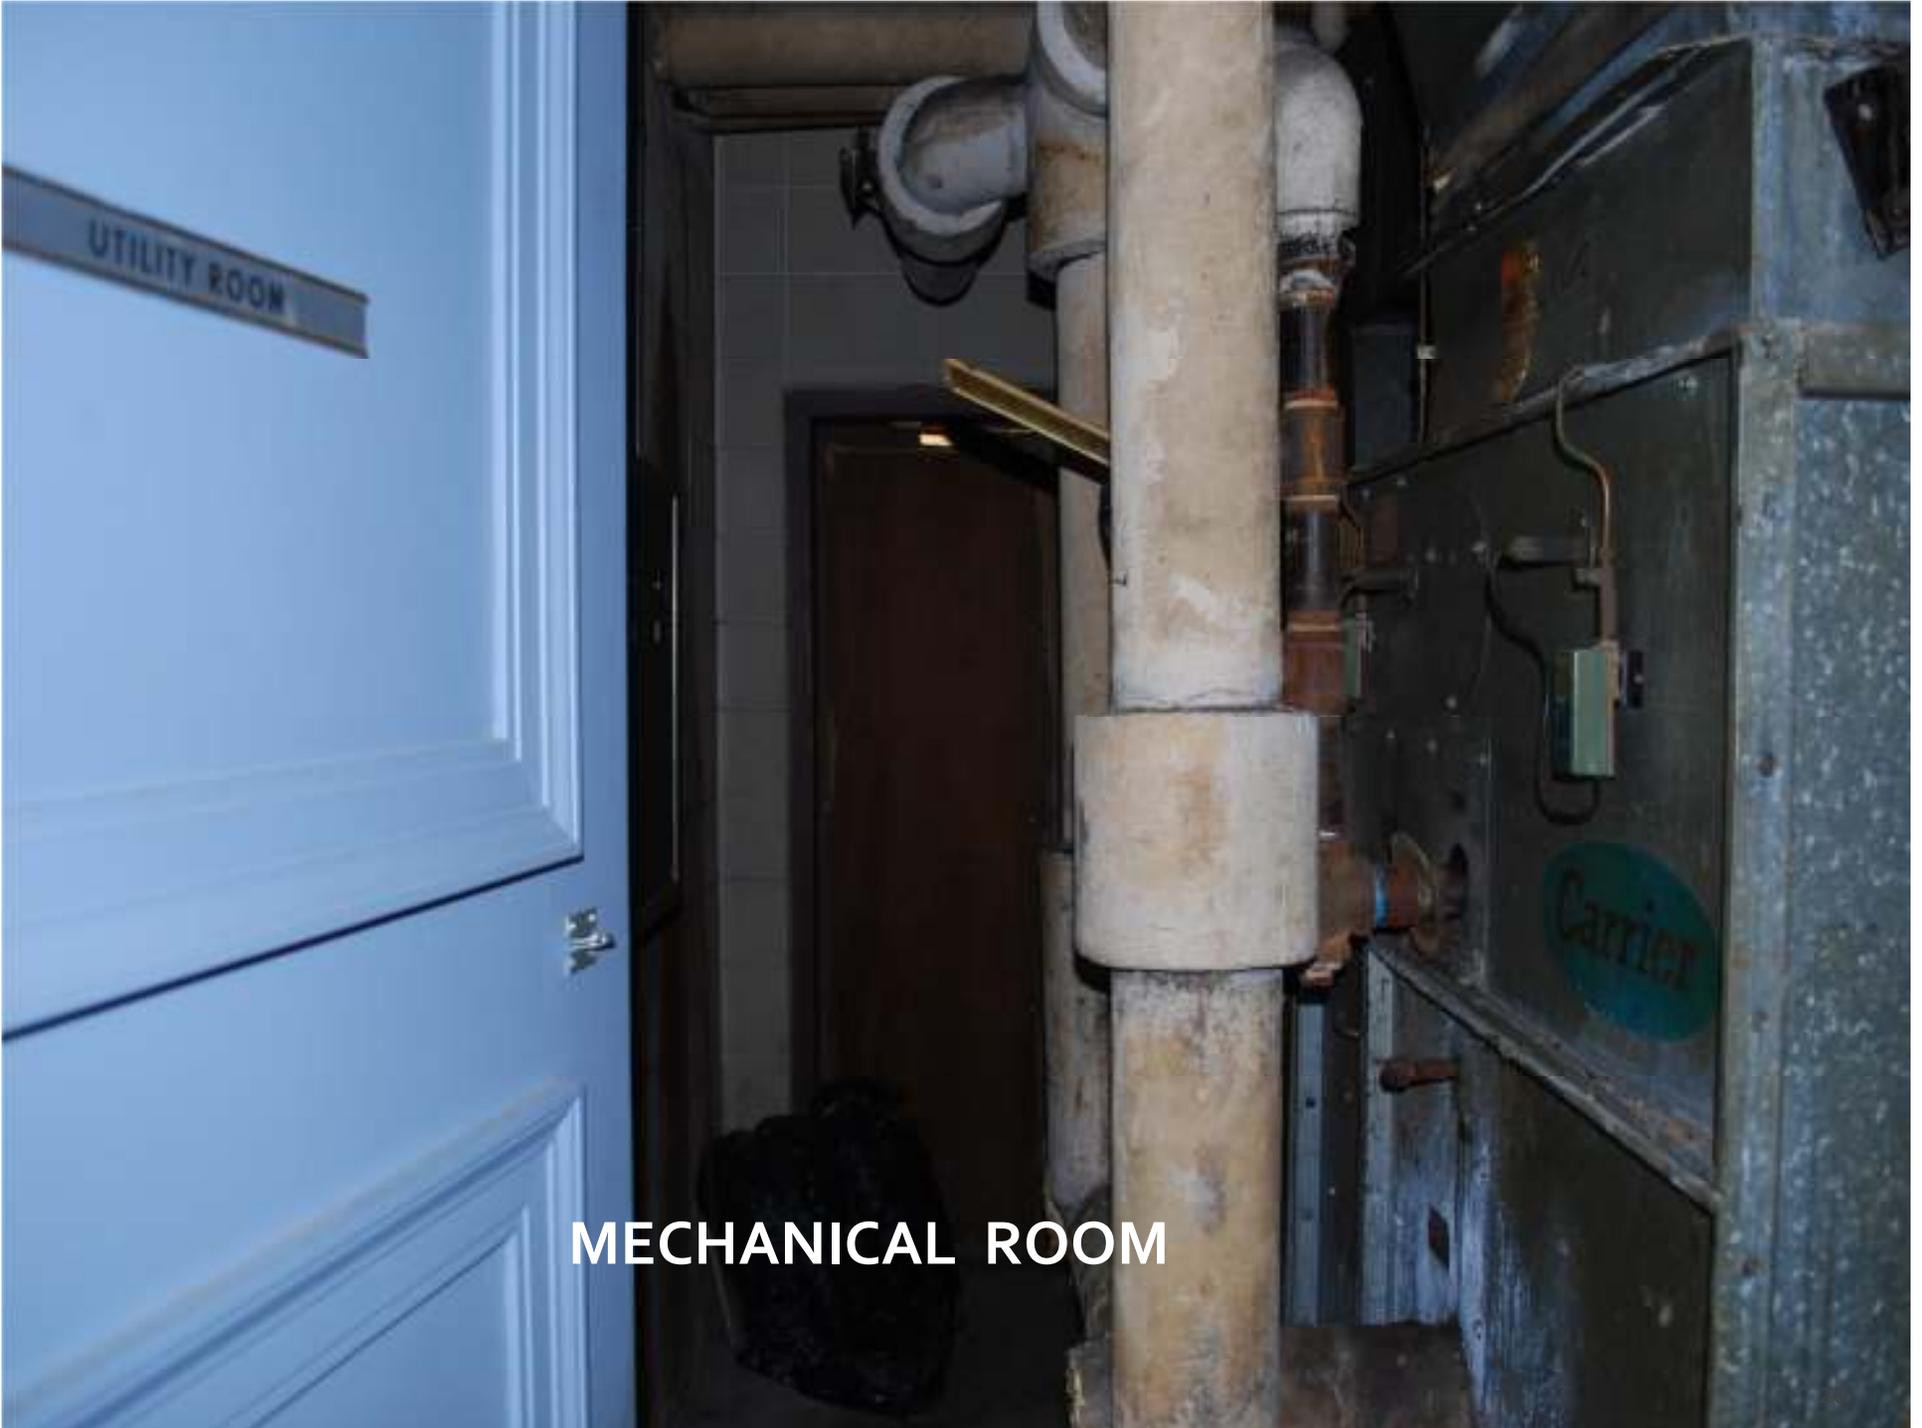
MECHANICAL ROOM

- Building Heating & Air Conditioning units are shared with the Courthouse in a central plant
- The central plant contains a cooling tower, boiler and chiller units
- An additional air-cooled chiller provides air conditioning when the main chiller is shut down
- Duct work inside the building is in poor condition

- Decentralize the heating & air conditioning
- Install new units in order to be able to heat and air condition in zones
- Remove & replace existing duct work

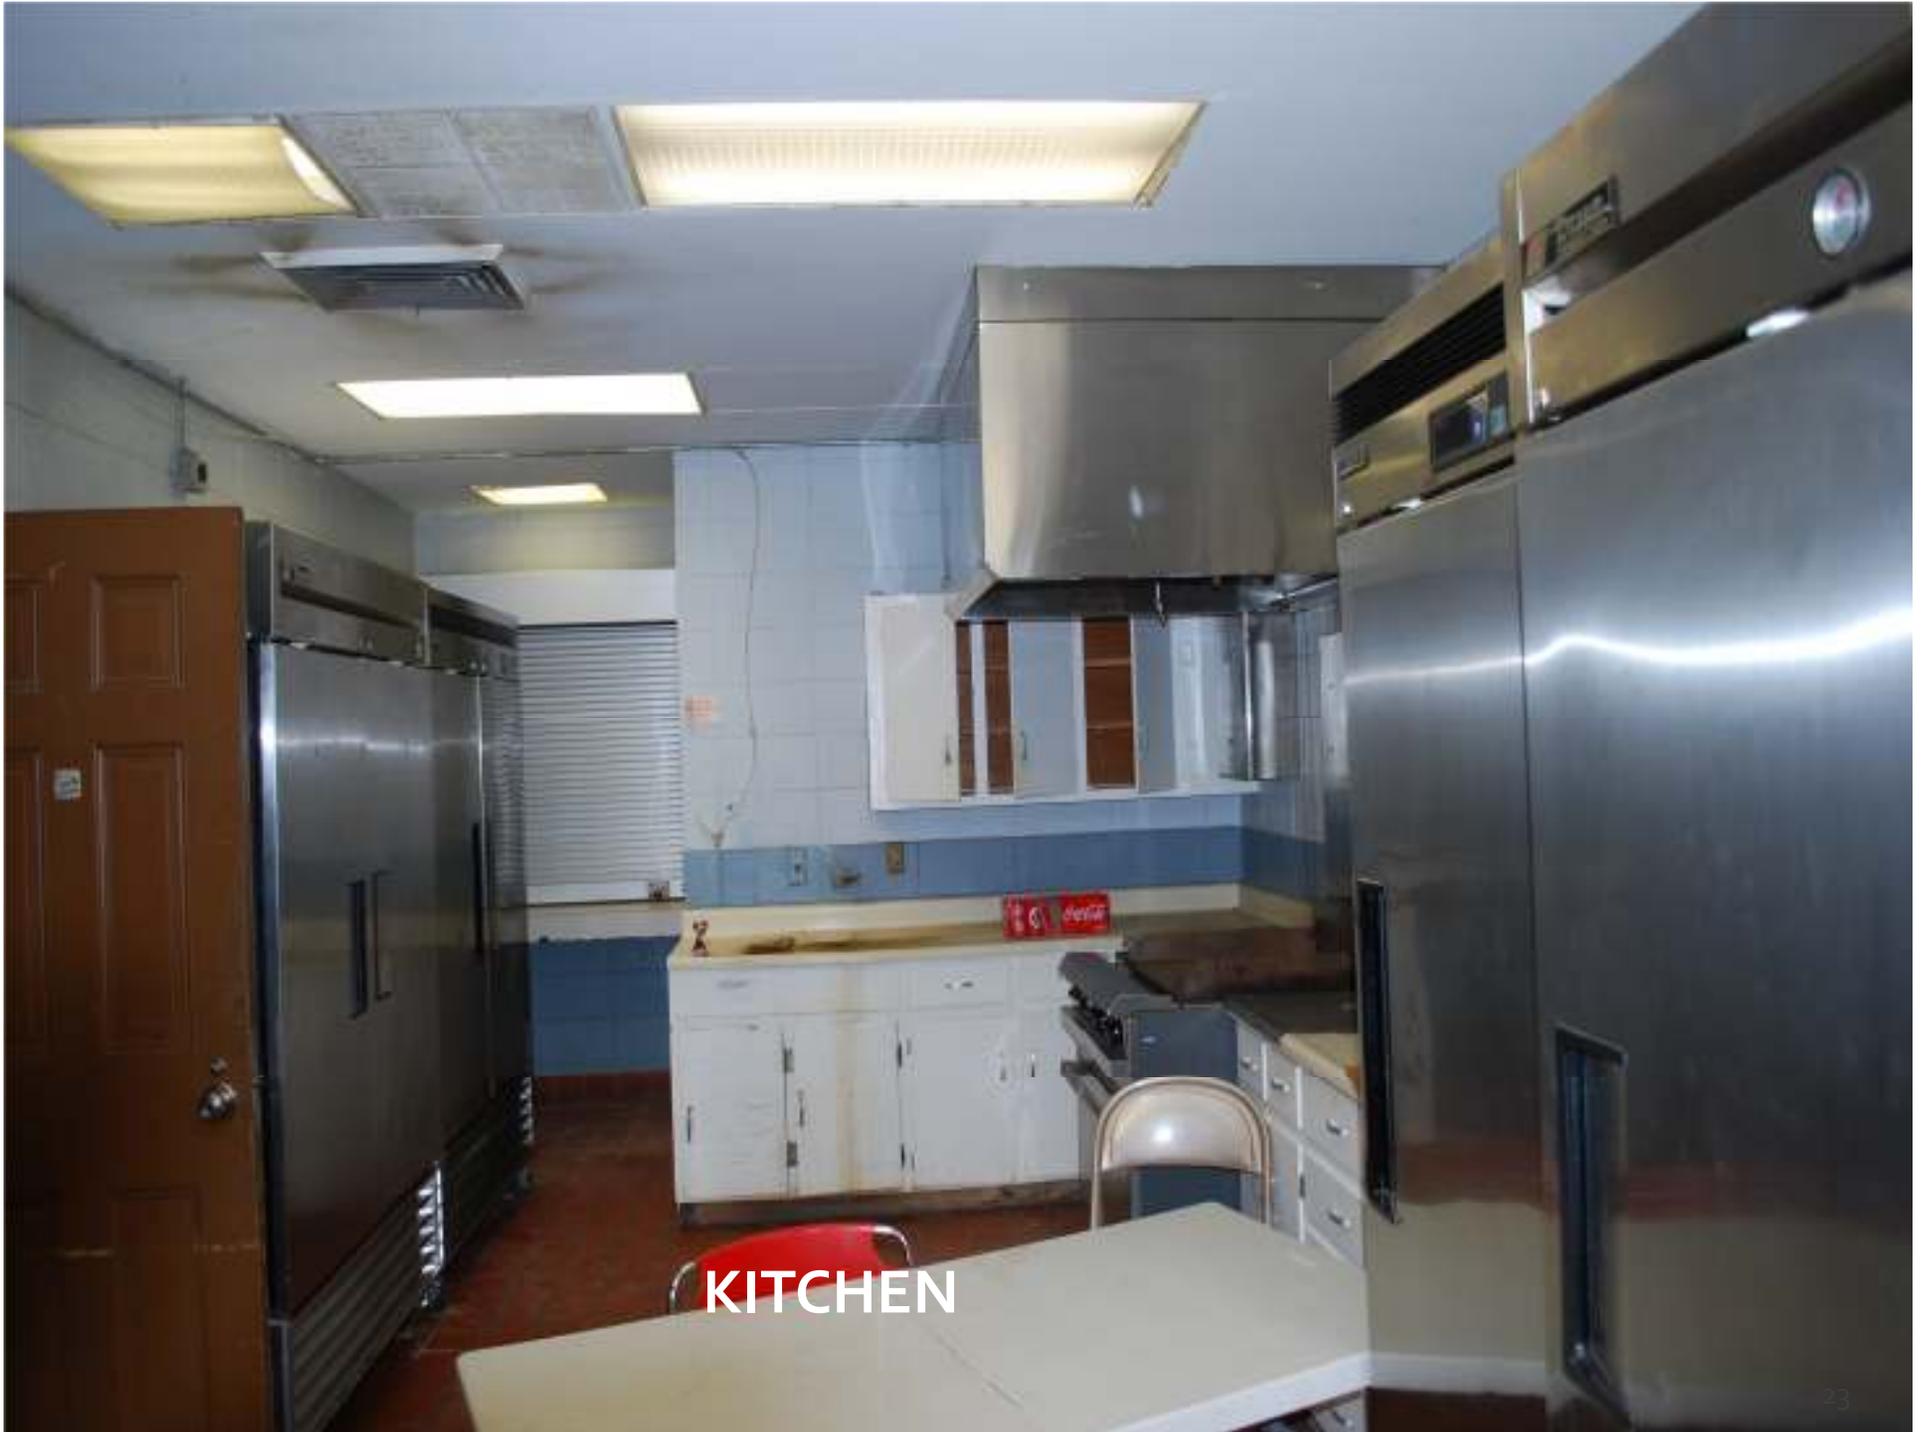
KITCHEN

- Existing kitchen & toilet is functional
- There are reports of damaged sewer lines
- Laundry room area is need of upgrades of water heaters

- Install ADA compliant toilet
- Depending on use, existing kitchen could be downsized to be a warming kitchen/break area
- Run a camera in sewer lines to locate damaged areas
- Reduce the 6" sewer line to 4" sewer line and possibly sleeve in the existing lines
- Replace water heaters

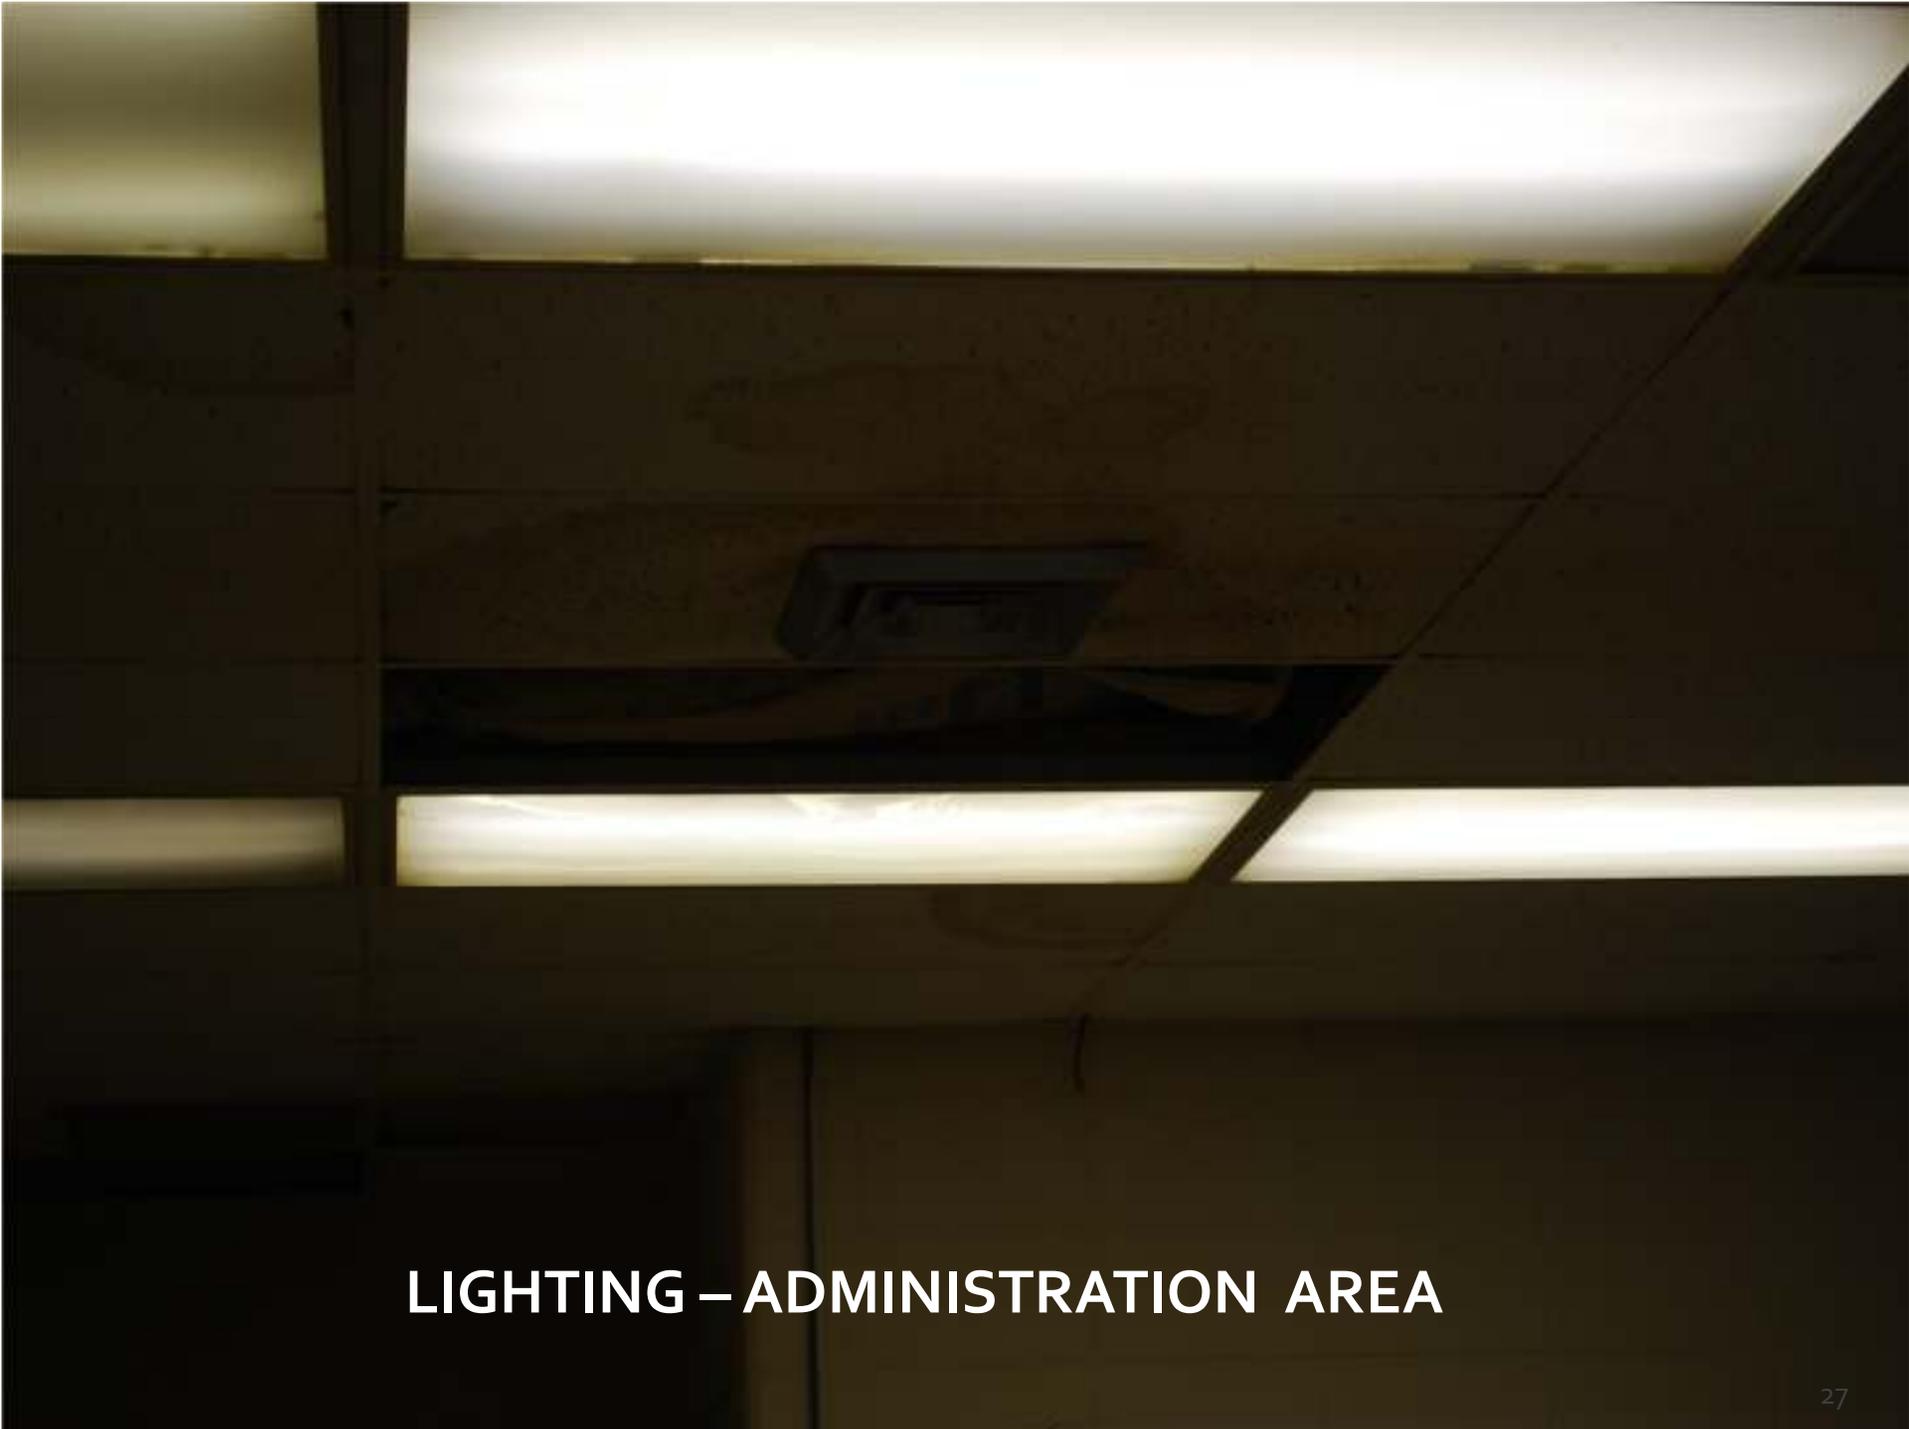
LIGHTING – ADMINISTRATION AREA

- General lighting in what was the administrative area is adequate
- Many lighting fixtures are in need of repair or replacement
- Lighting in the detention area is very poor
- Exterior lighting is minimal
- Depending on use, a fire alarm/smoke detection system may be required

- Replace all lighting fixtures with new fluorescent lighting with parabolic lens

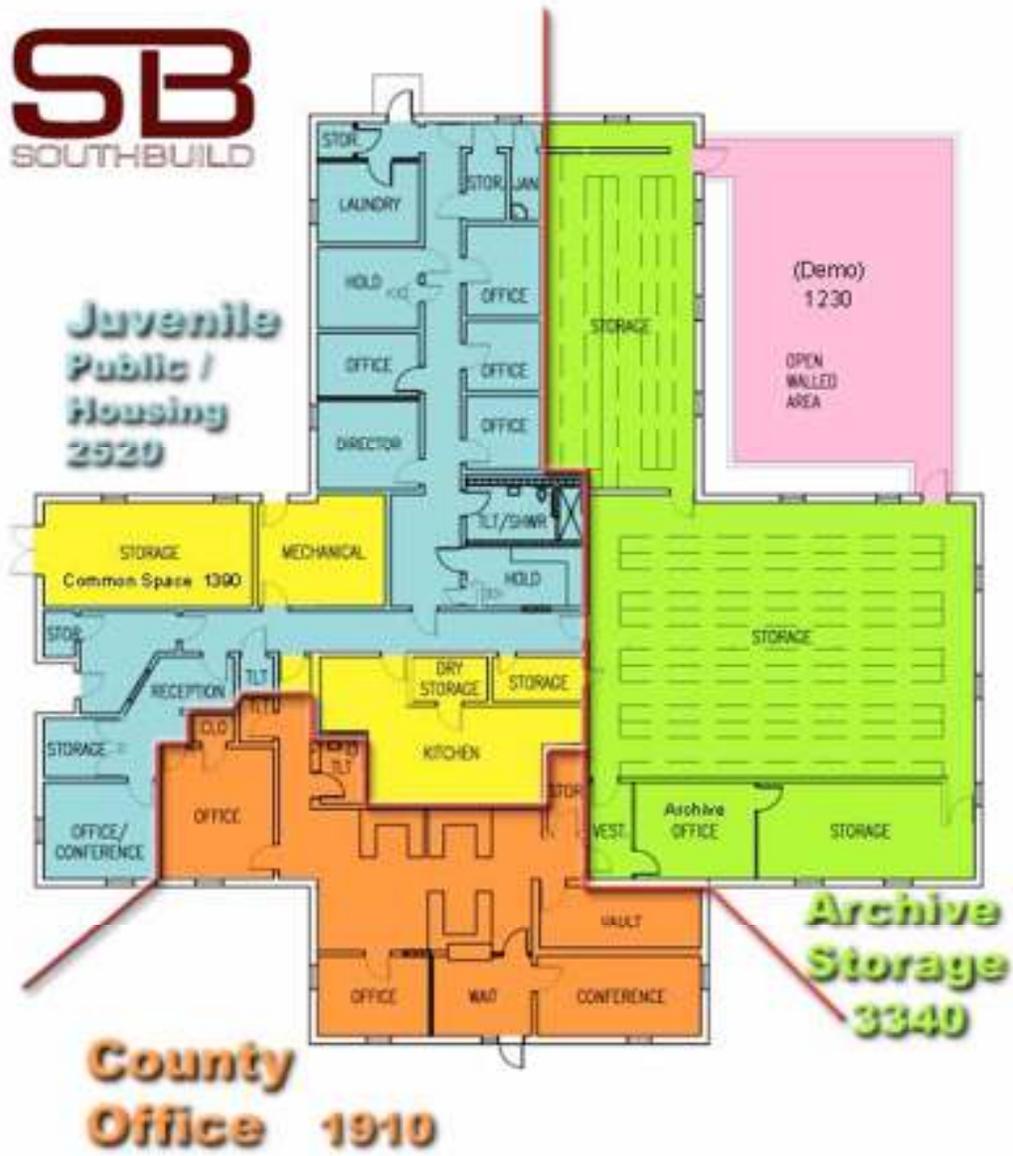
ROANE COUNTY EXISTING JAIL REUSE

- Convert areas from side entrance to holding areas and down the hall to laundry room to Juvenile Probation
- Consolidate Juvenile Probation with temporary housing for juveniles in existing holding cells (renovation will be required)
- Move one of the first floor offices to renovated administration area on Race Street side of the building
- Use detention areas for storage and archive office
- Cost estimate of \$700,000 as of May 2010

Juvenile
Public /
Housing
2520

County
Office 1910

Archive
Storage
3340
